04 72 8163.9-2214
Louis Renner GmbH
Our Ref.: H1112 EP

Contact piece made of tungsten provided with a corrosion-resistant layer made of tin

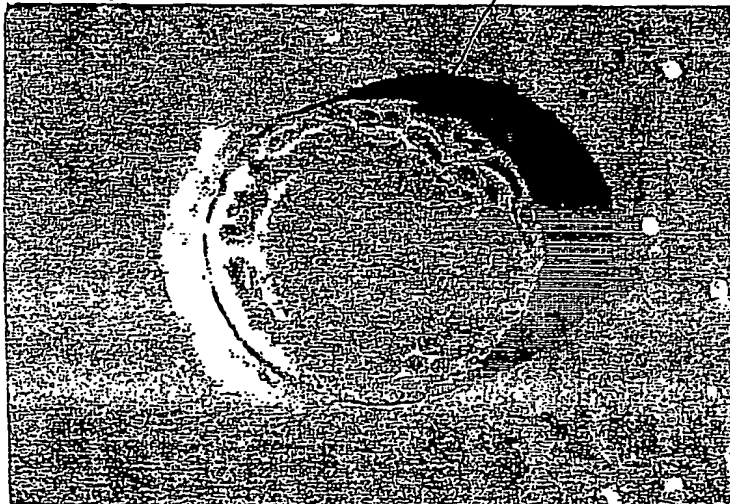
Fig. 4

The result after 48 hours is depicted in Figures 2 and 4. As compared with the non-corroded standard (Fig. 3), the galvanically after-treated rivets show only slight

haziness at the contact surface. As regards the reference without galvanic after-treatment, however, the W-surface is covered with thick greenish-brown crusts which, starting from the periphery at the Cu solder, extend into the tungsten surface, in part up to its center. These crusts are probably inorganic salts of copper and tungsten. If these are located between the closed contacts of a horn, this will result in an increased contact resistance and, consequently, the break down of the horn.
